NASA CR-54323  
EOS REPORT 4920-Final

# ION ROCKET SYSTEM RESEARCH AND DEVELOPMENT

NATIONAL AERONAUTICS AND SPACE ADMINISTRATION

**ELECTRO-OPTICAL SYSTEMS, INC.,** Pasadena, California  
A Subsidiary of Xerox Corporation

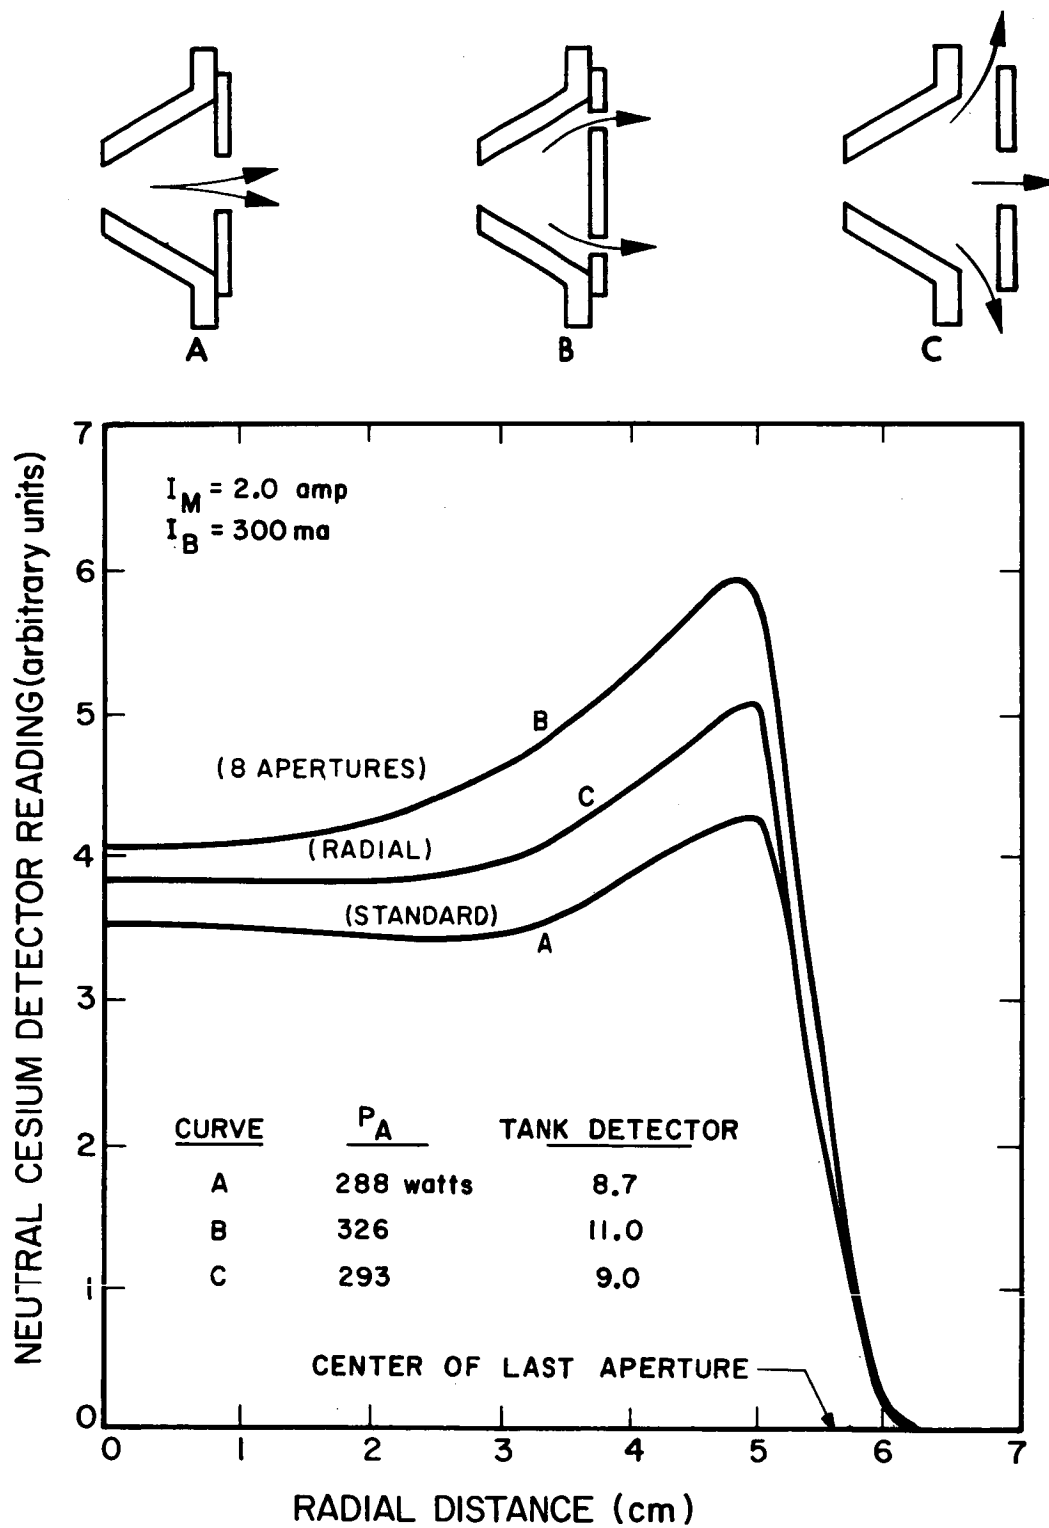
FIG. 90 NEUTRAL EFFLUX DISTRIBUTIONS WITH DIFFERENT CATHODE ORIFICE CONFIGURATIONS

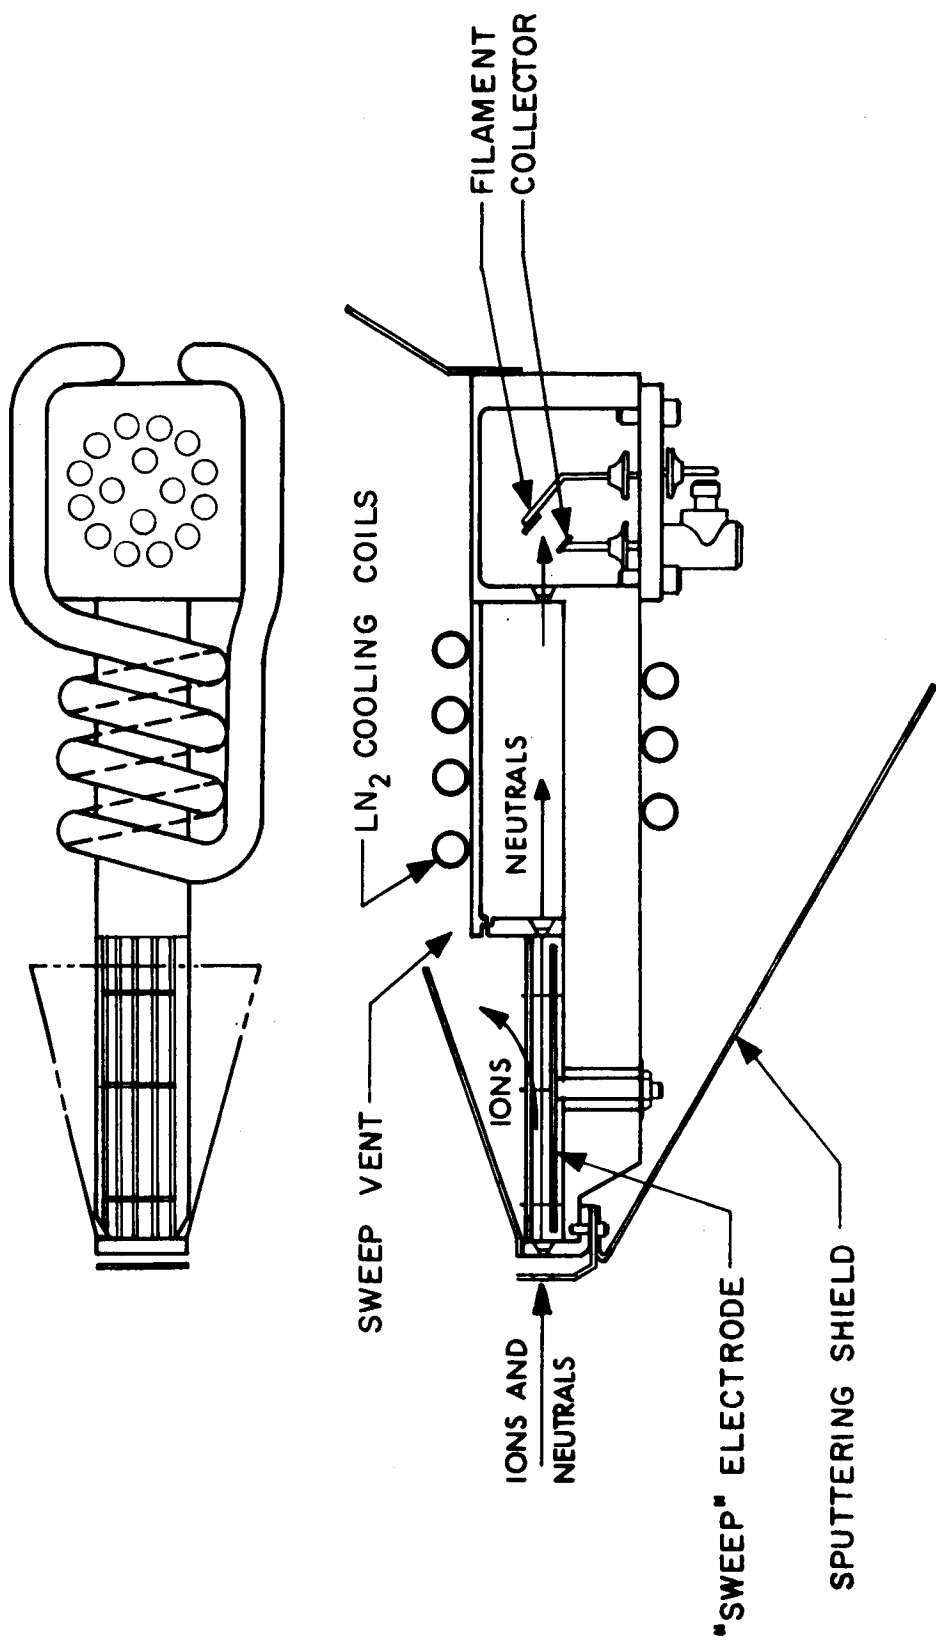
FIG. 95 LIQUID-NITROGEN-COOLED NEUTRAL DETECTOR

This detector had a more effective sweep system than other detectors (longer sweep length and improved venting) and used  $\text{LN}_2$  cooling to condense cesium out of the filament housing. A schematic of this neutral detector is shown in Fig. 95. Ions entering the front aperture see a transverse electric field which deflects them up through the grid and out of the detector. Two apertures are used after the sweep electrodes so that reevaporated cesium from the sweep area will not be measured. The entire detector is liquid-nitrogen cooled to capture stray cesium atoms on the walls of the device, thus preventing a cesium pressure buildup. Neutral cesium atoms arriving at the hot tungsten filament are ionized by surface ionization and repelled from the filament, which is biased positive with respect to the detector walls. A portion of these ions are intercepted by the collector and measured. The detector was mounted on the probe drive used for the previous tests so that neutral efflux measurements as a function of radial position could be obtained. The collimated

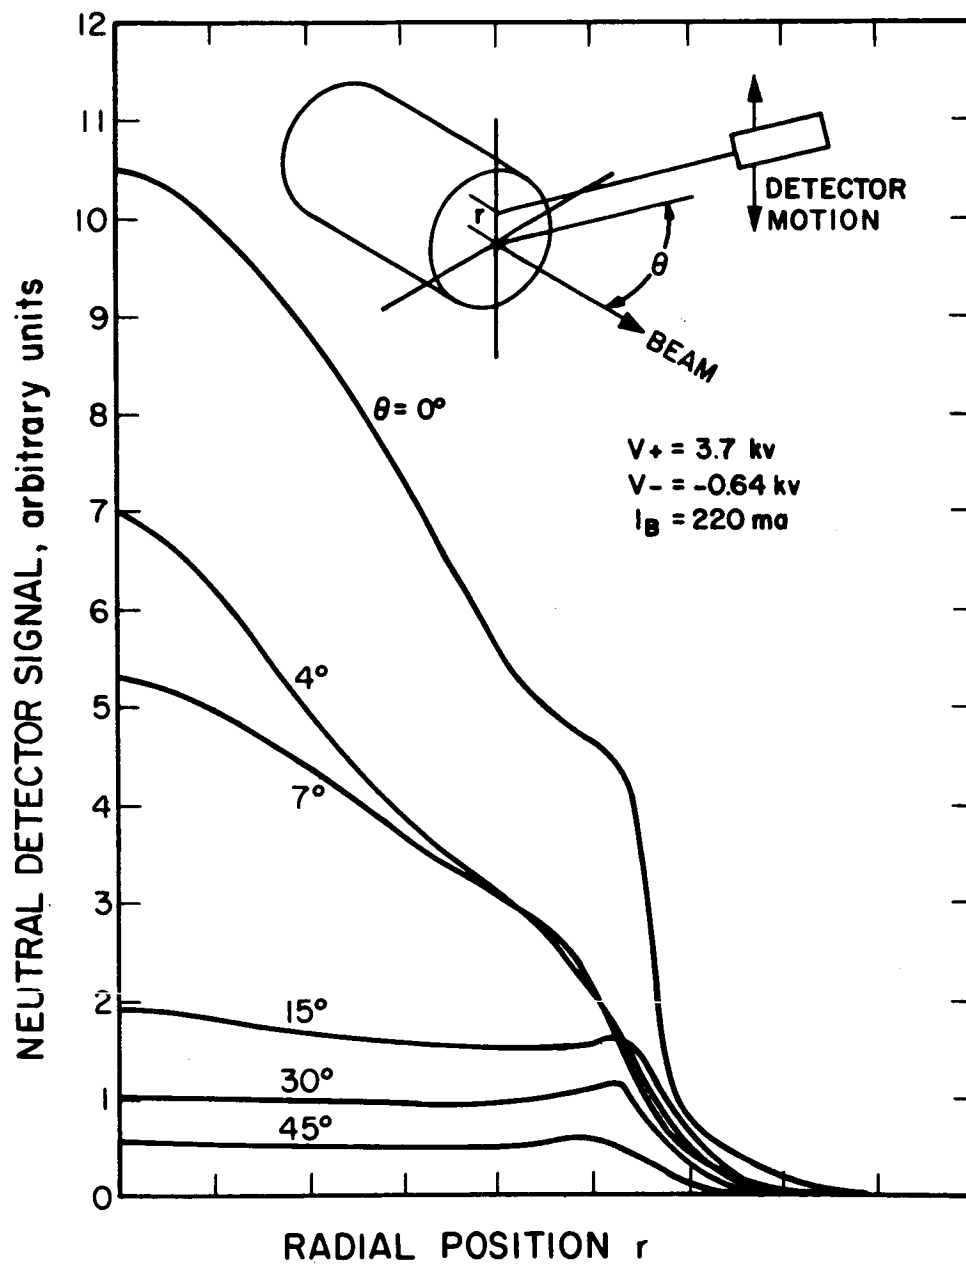
FIG. 98 NEUTRAL EFFLUX DISTRIBUTIONS

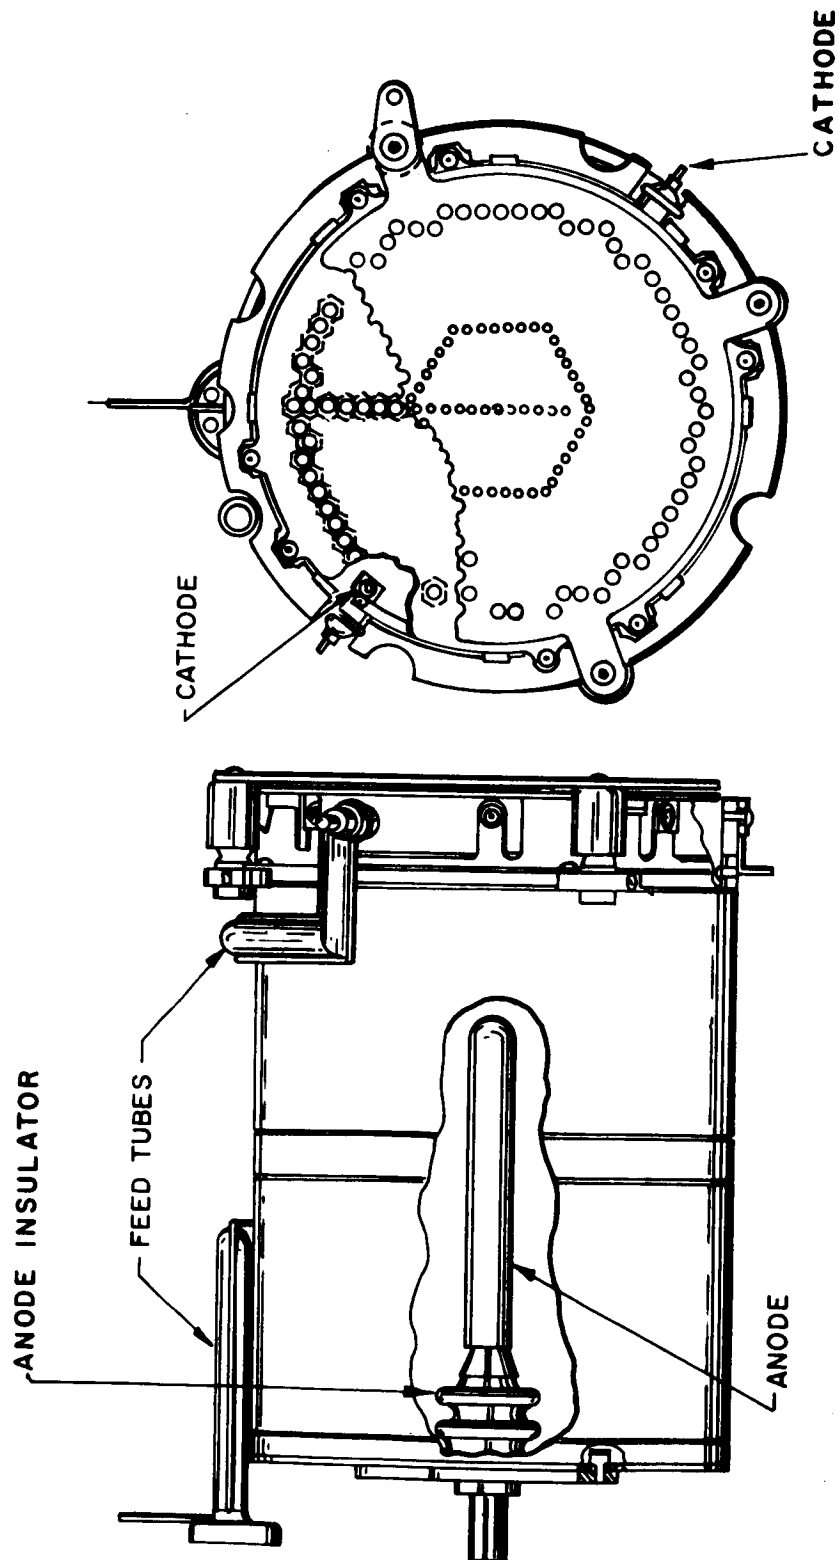
FIG. 99 INVERTED ENGINE DESIGN

The design is shown in Fig. 99. A heated feed tube assembly was used to bring cesium to the cathodes mounted at the screen end of the chamber. The engine shell was a DE shell with an extension at the screen end to provide for mounting the cathodes. The cathodes had heated tantalum emitters similar to those of the DE cathode but smaller in size. This device was operated but no distribution data

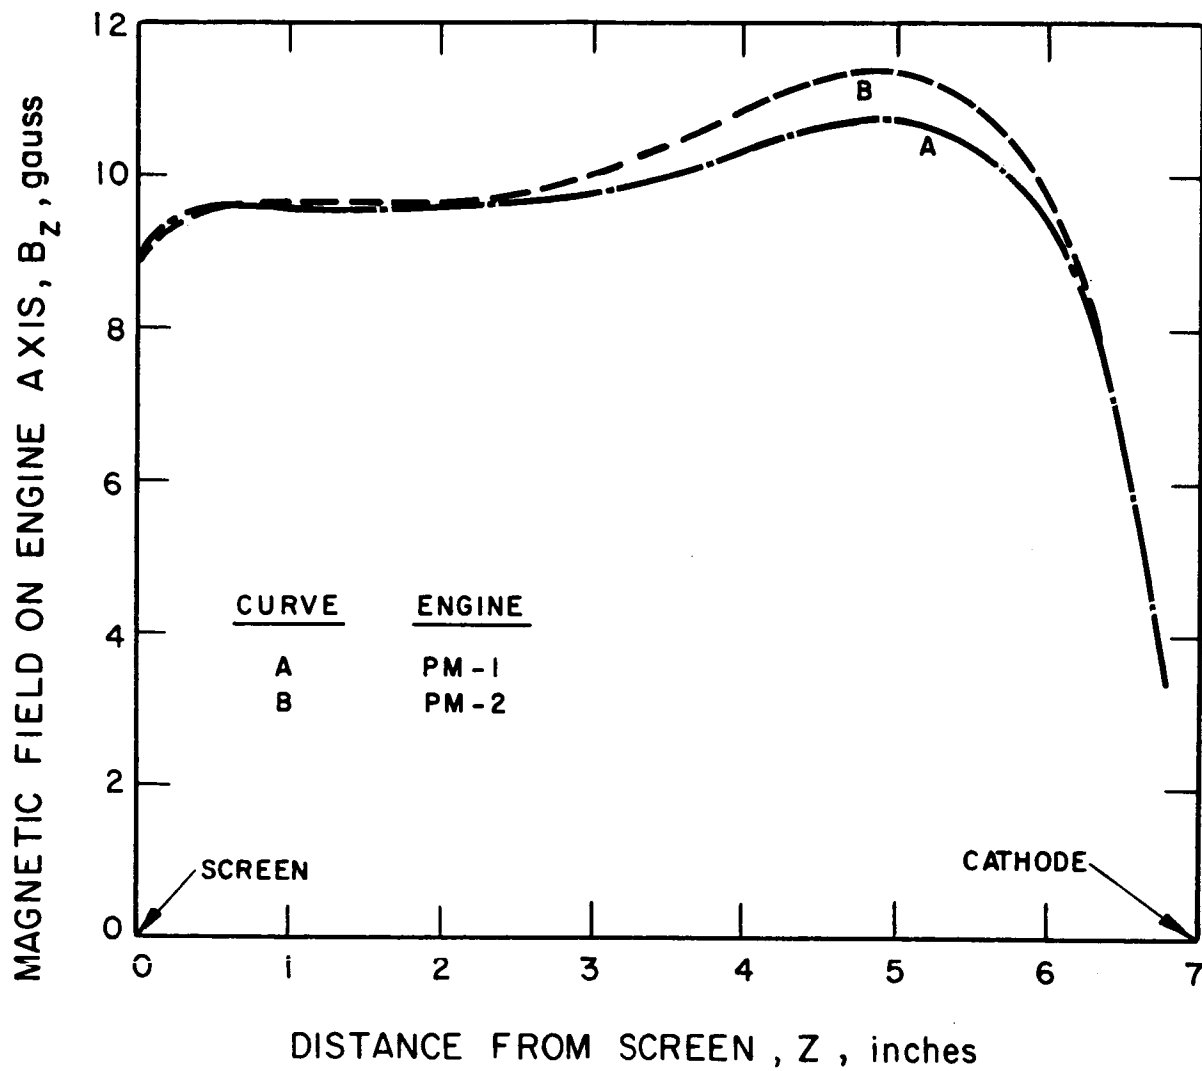
FIG. 100 PM ENGINE FIELD CONFIGURATIONS

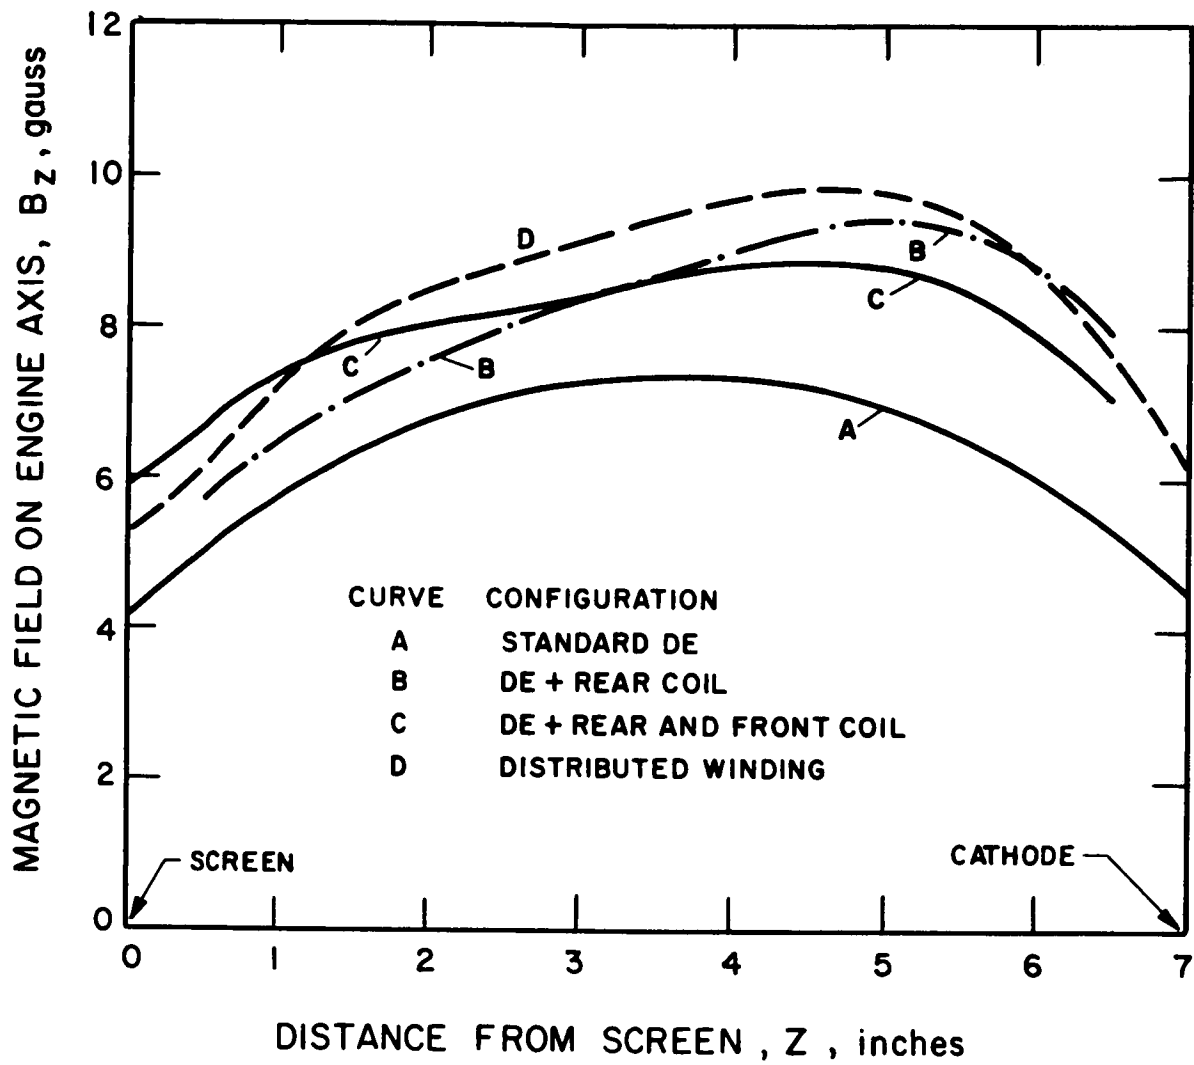
FIG. 101 ELECTROMAGNET FIELD CONFIGURATIONS

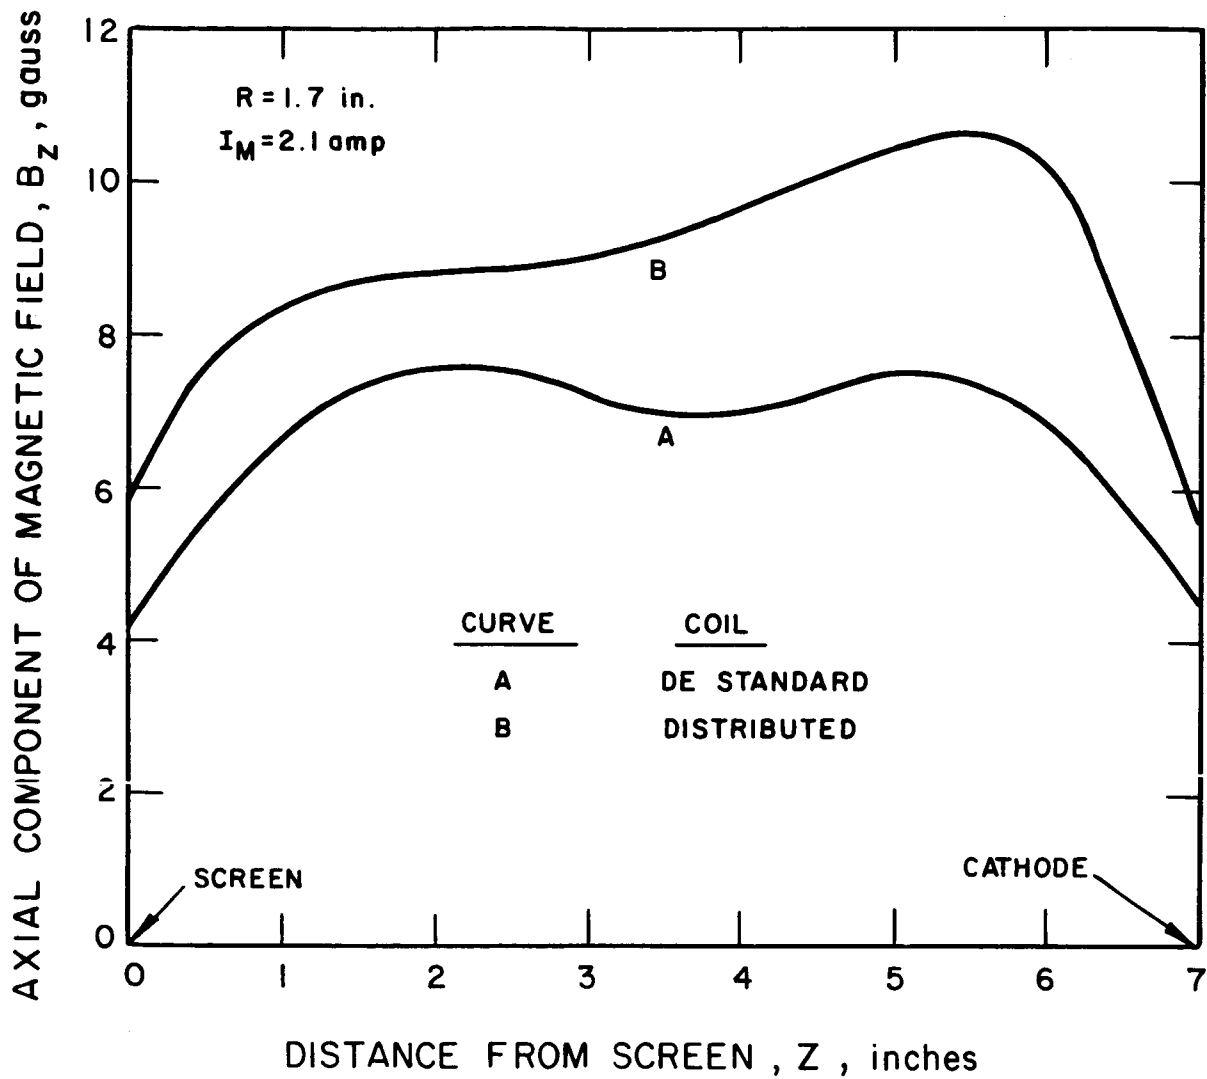
FIG. 102 DE AND DISTRIBUTED COIL FIELDS OFF-AXIS

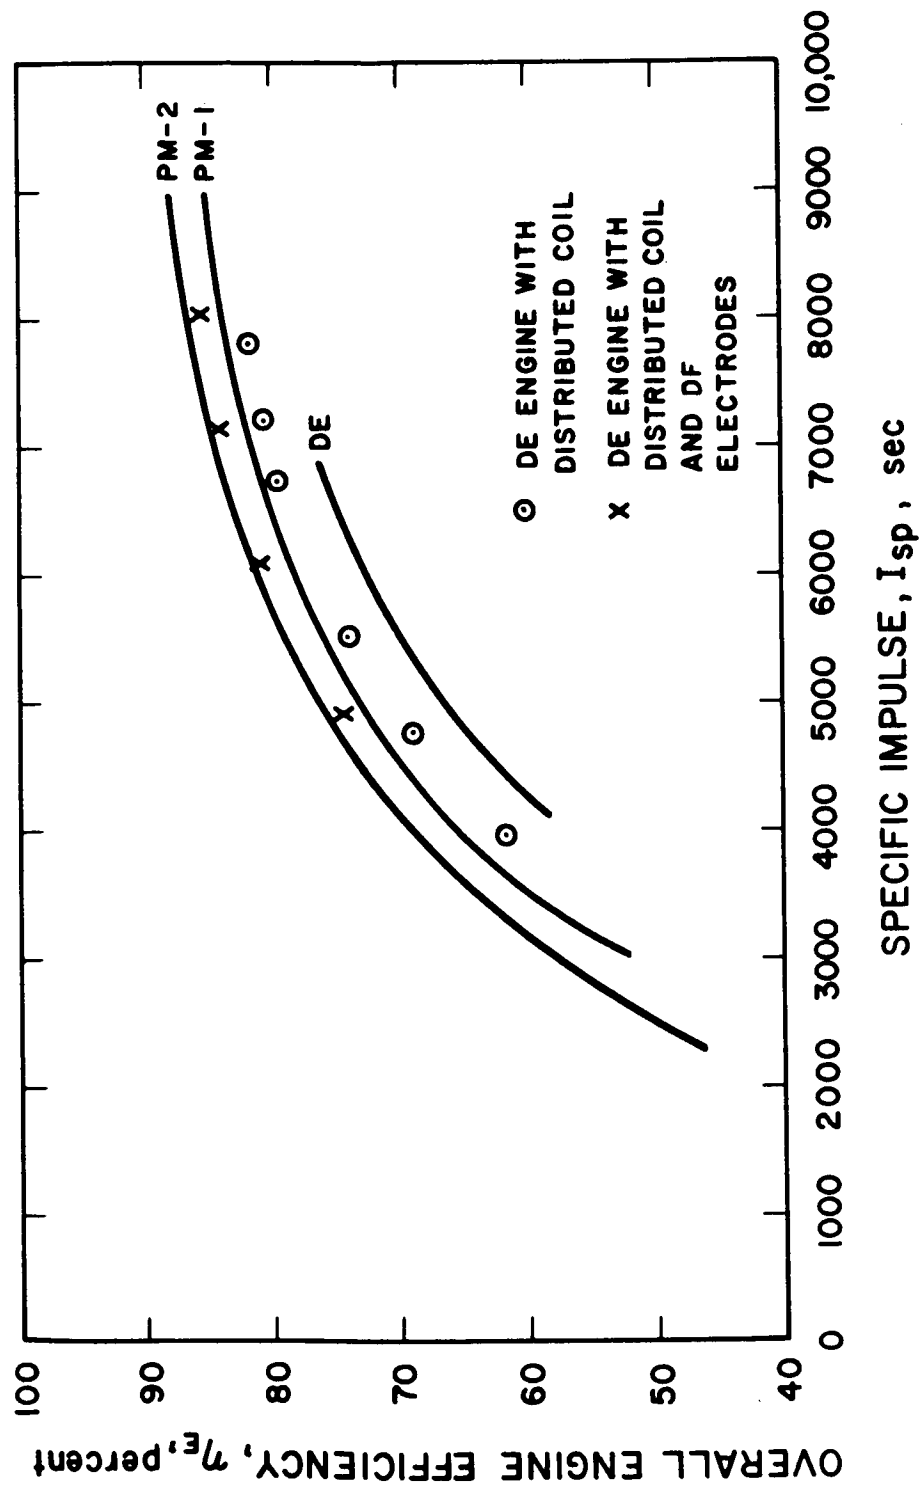
FIG. 103 DISTRIBUTED COIL ENGINE EFFICIENCIES

The engine with the distributed coil was operated and the performance obtained is shown by the circled data points in Fig. 103. Performance was about four percent above the DE level. The electrodes for the 750-hour test engine with the three aperture sizes were then placed on this engine to obtain a better match to the plasma distribution. Subsequent operation was found to be 8 percent more efficient than the DE engine as shown by the X data points in Fig. 103.

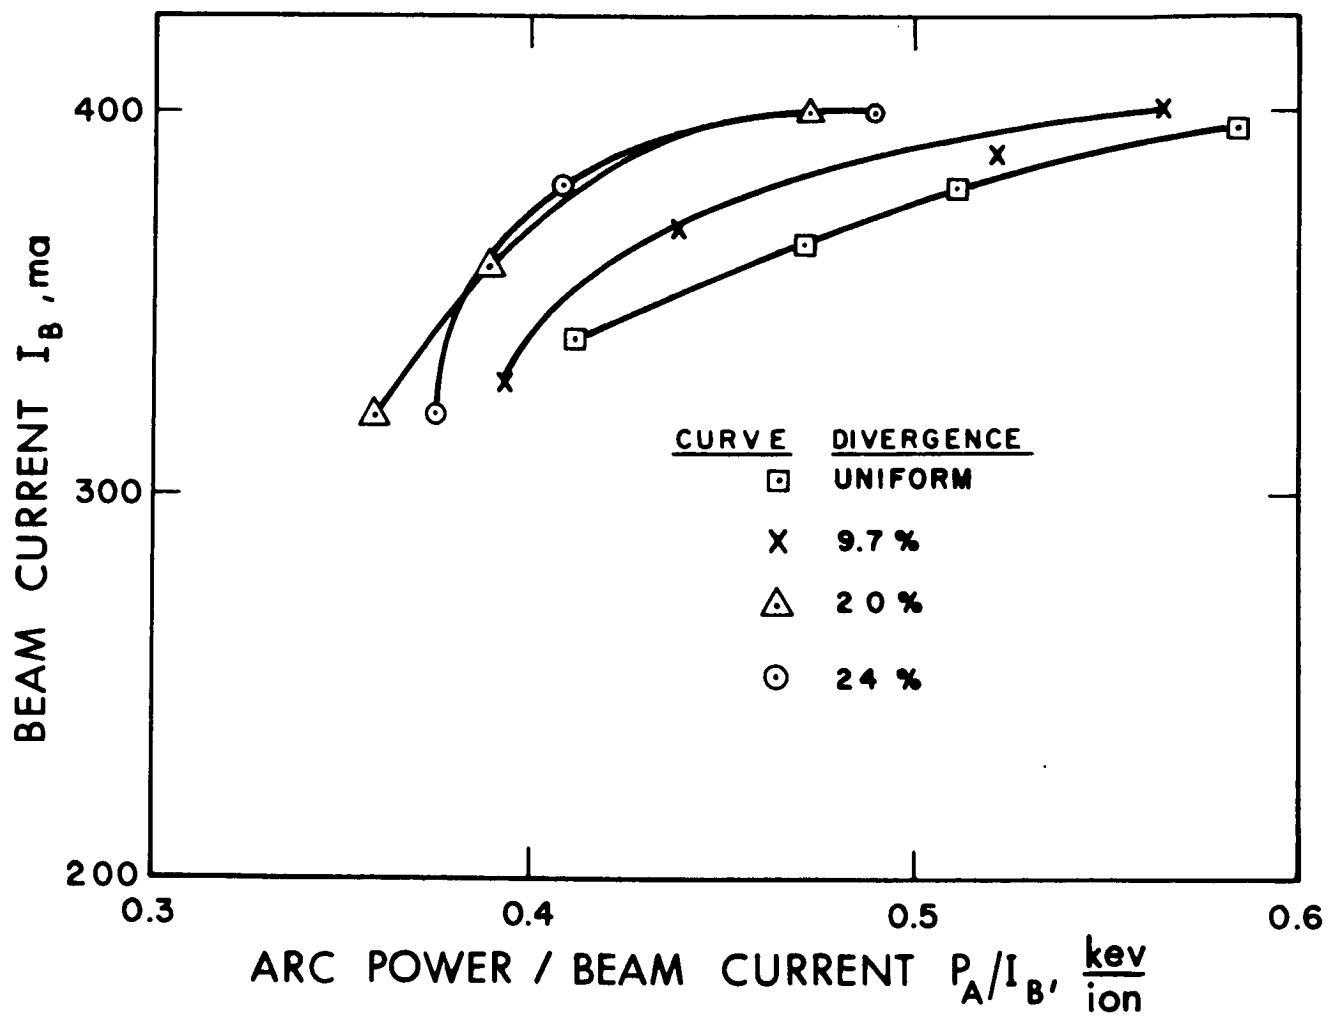
FIG. 104 SOURCE EFFICIENCY VARIATIONS WITH MAGNETIC FIELD DIVERGENCE

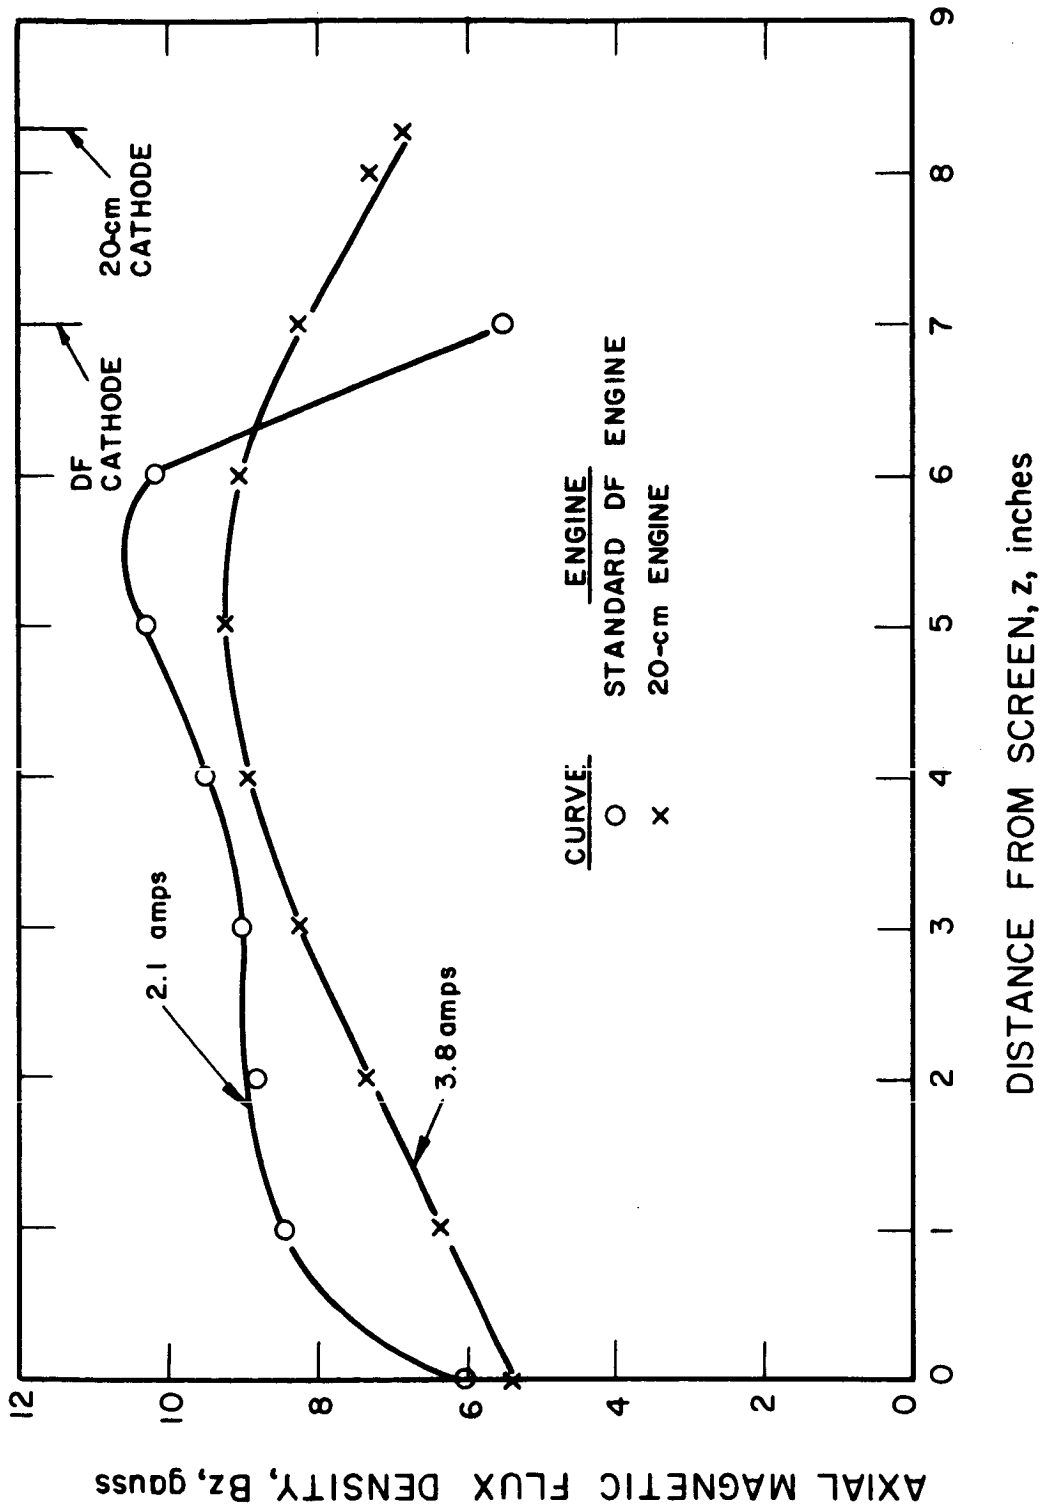
FIG. 105 AXIAL MAGNETIC FIELD COMPONENTS OF DF AND 20-cm ENGINE

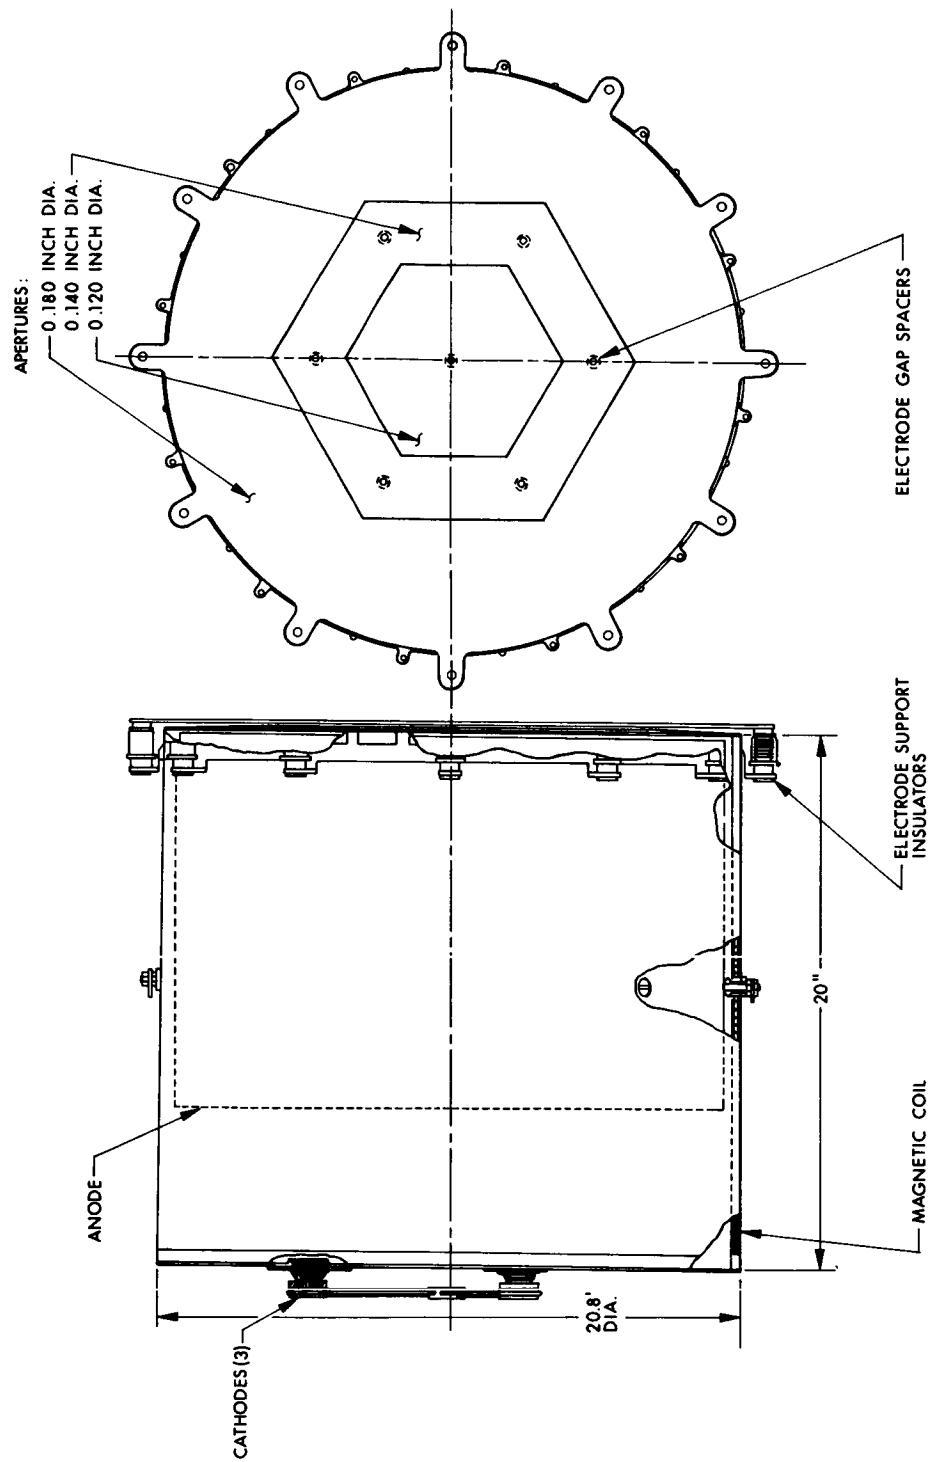
FIG. 109 30 KW ION ENGINE

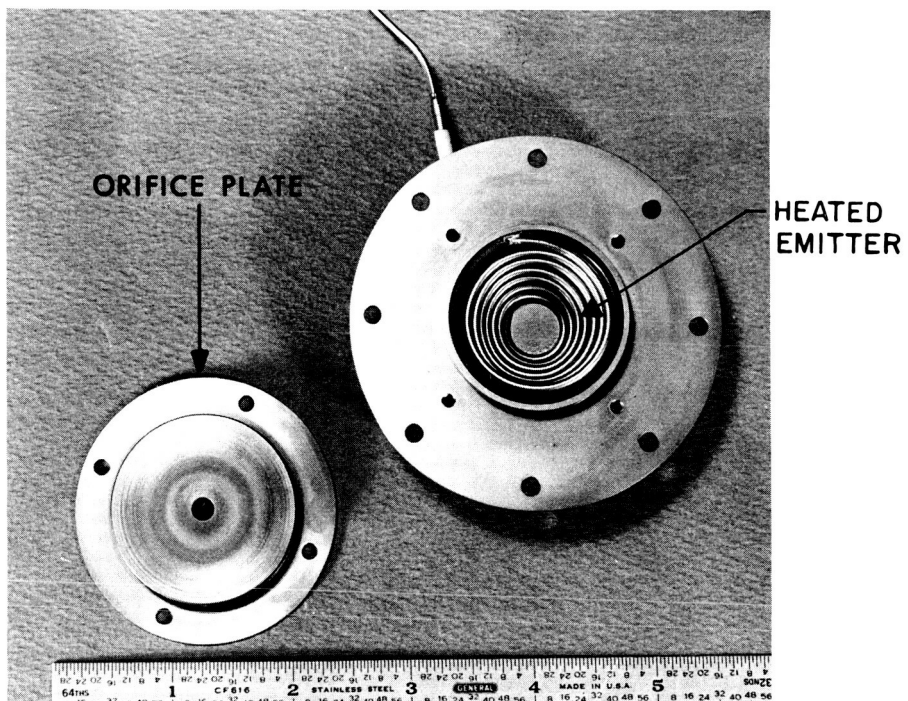
FIG. 110 INTERNALLY-HEATED DE CATHODE WITH  
ORIFICE PLATE REMOVED

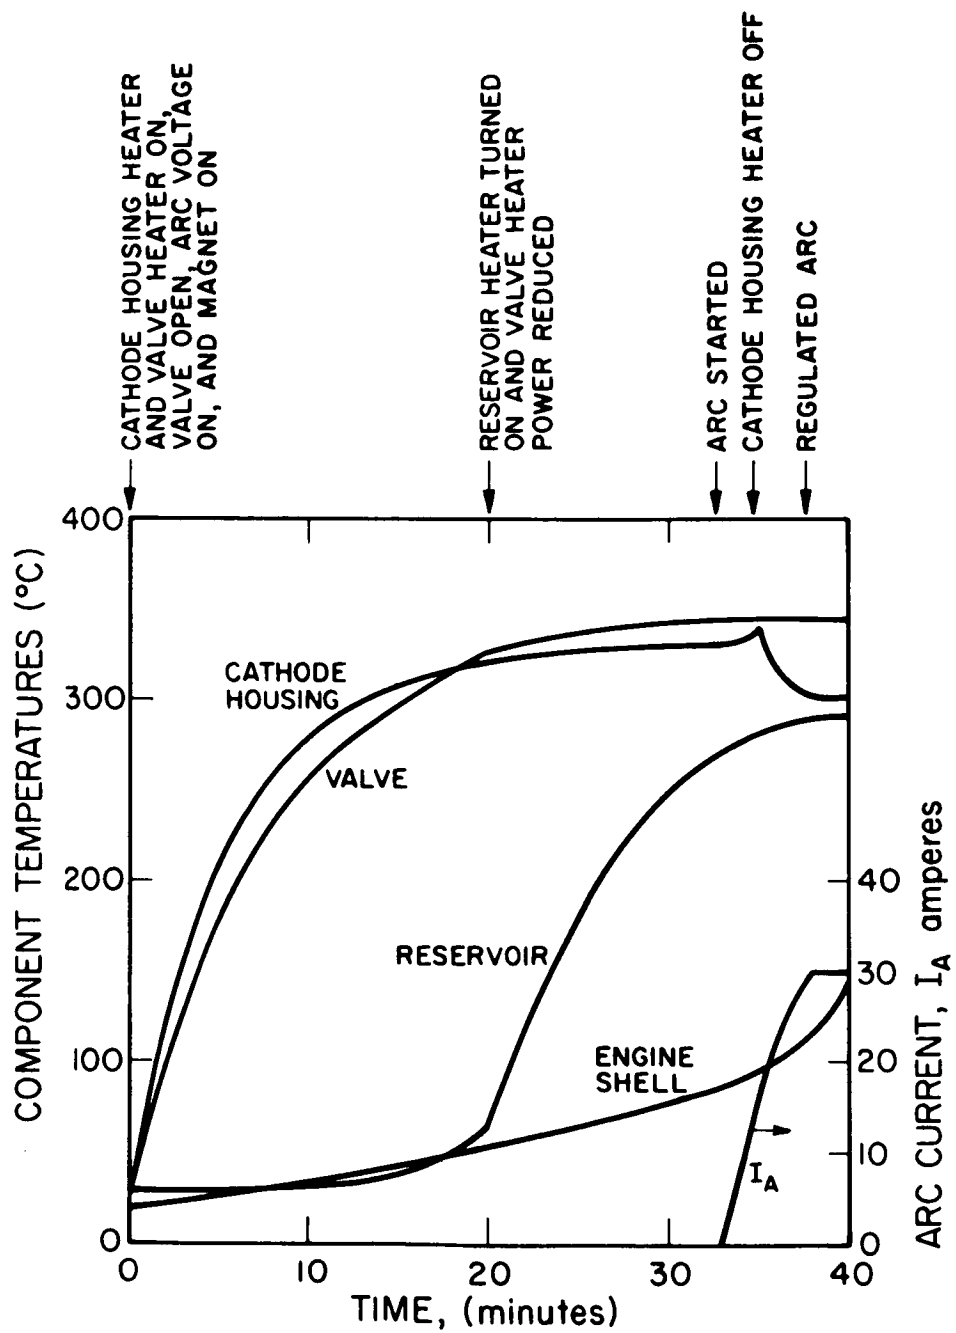
FIG. 111 COLD CATHODE START-UP PROFILE

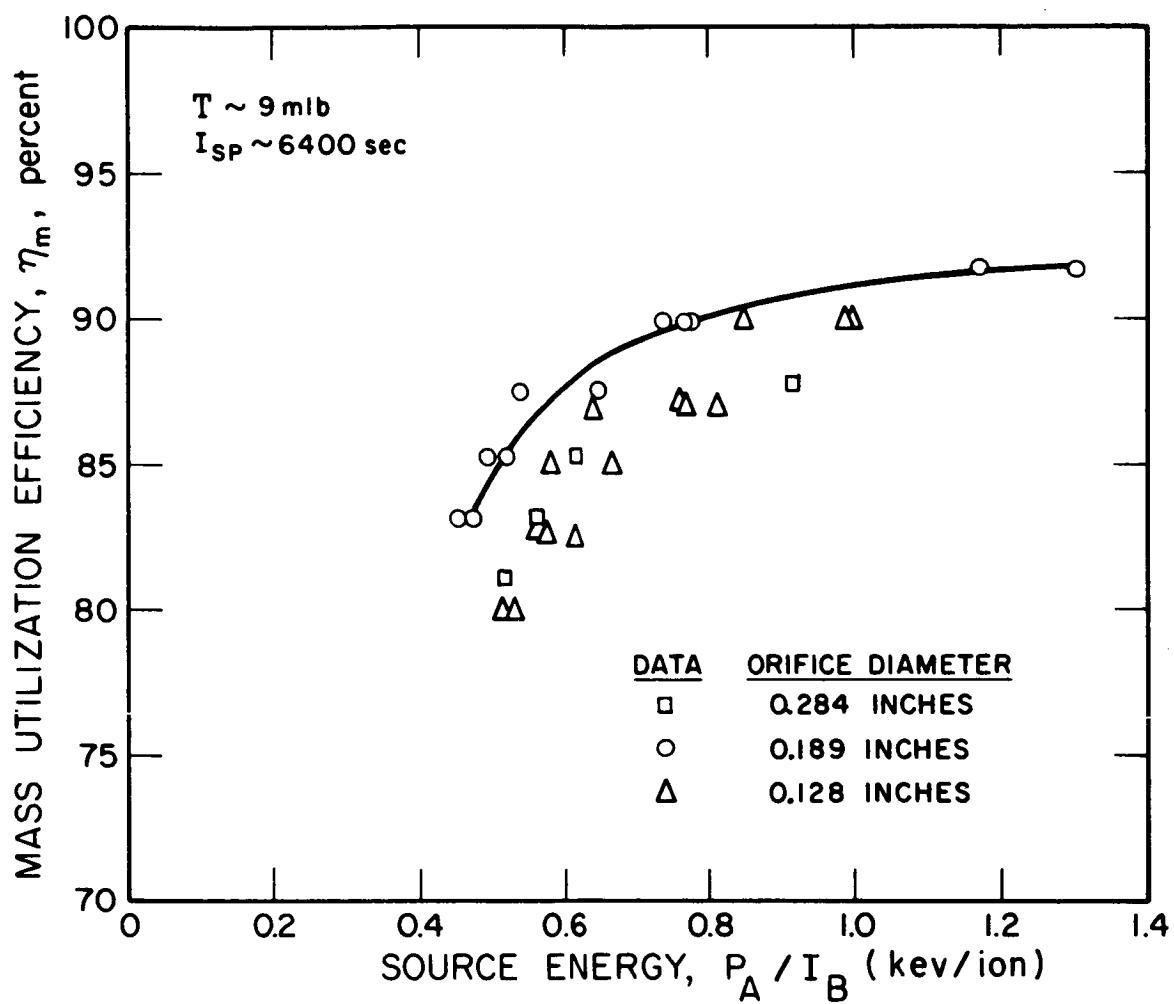
FIG. 112 EFFECT OF ORIFICE DIAMETER ON SOURCE EFFICIENCY

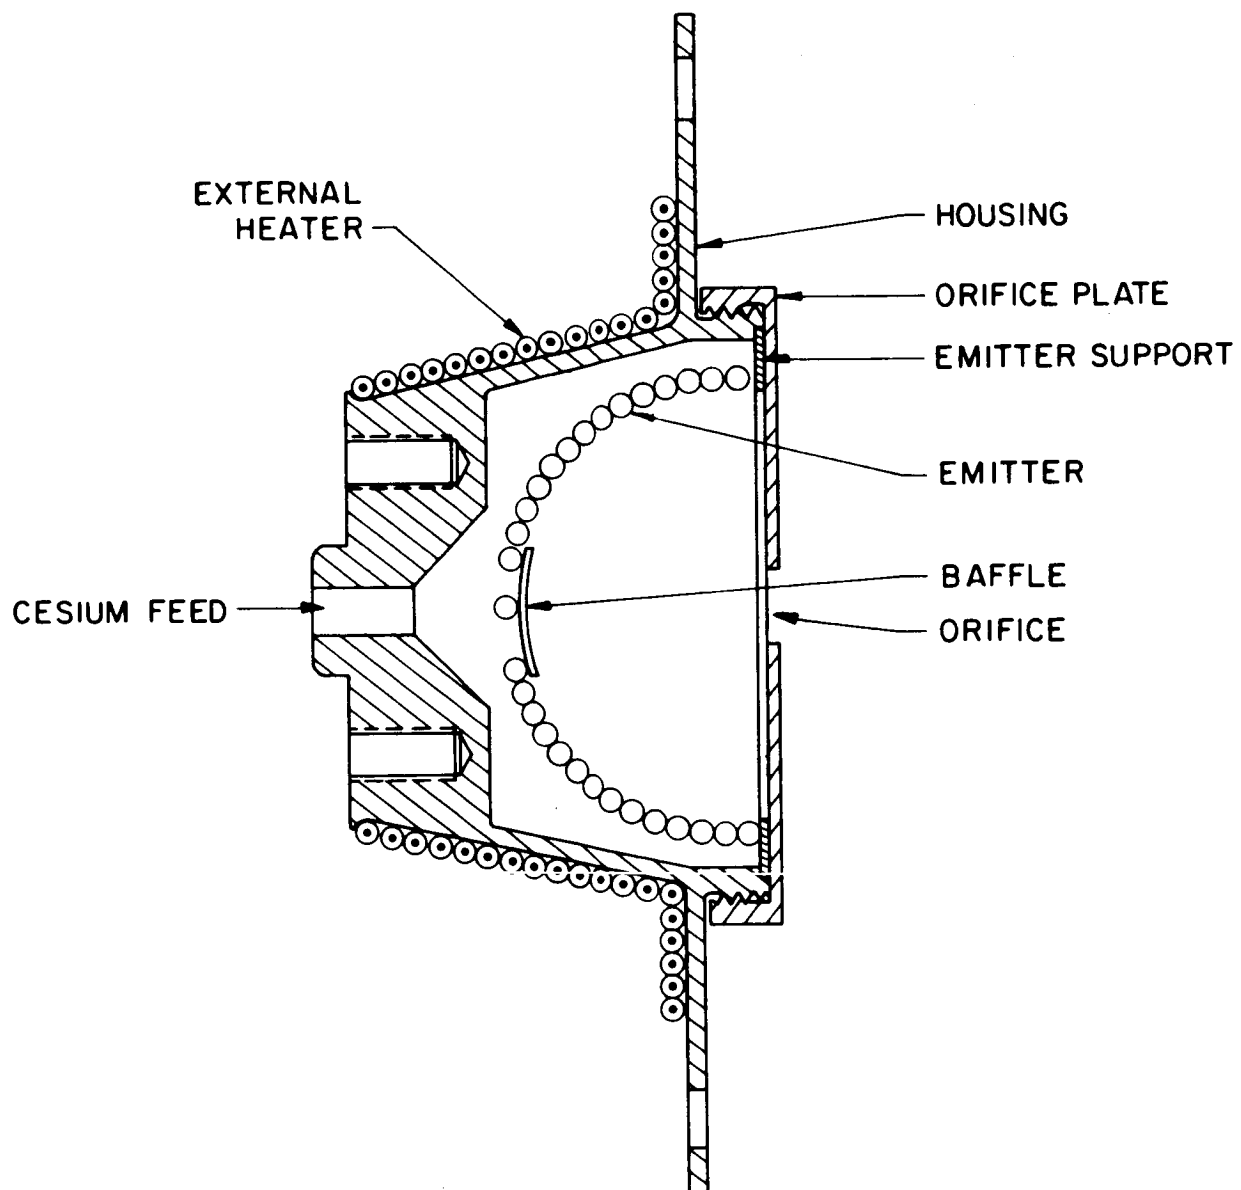
FIG. 114 EXTERNAL HEATER AUTOCATHODE DESIGN

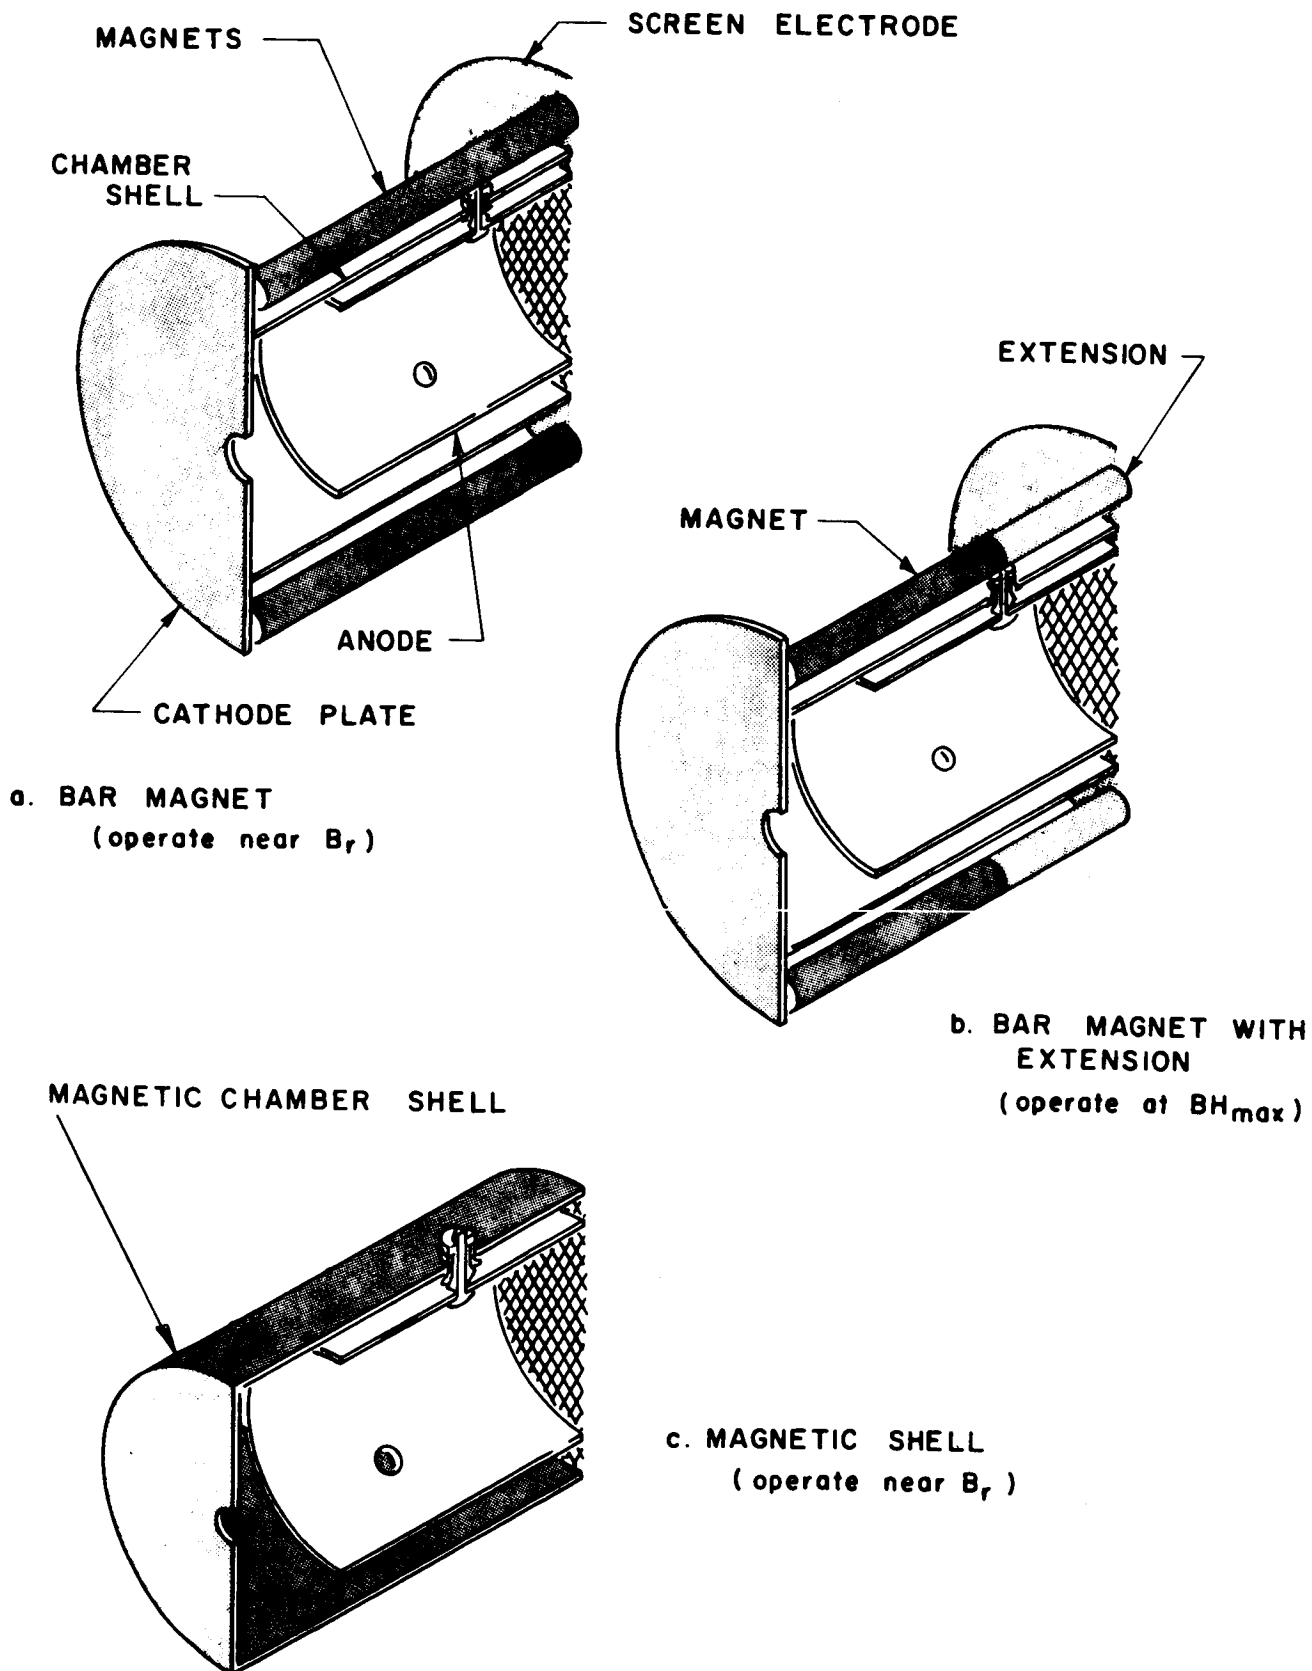
FIG. 116 PERMANENT MAGNET ENGINE CONFIGURATIONS

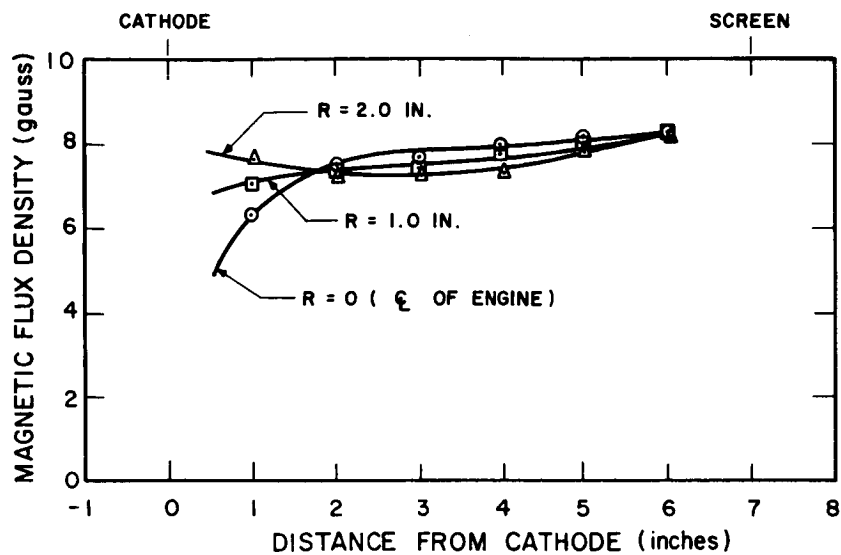
FIG. 118a AXIAL COMPONENT OF MAGNETIC FIELD OF DE ENGINE WITH PERMANENT MAGNETS
